**D6771.07-113-11-R0**  
**ACOUSTICAL PERFORMANCE TEST REPORT**  
**ASTM E 90 AND ASTM E 492**

**Series/Model: RCU 200 Rubber Underlayment**

**Specimen Type: Floor/Ceiling Assembly**

**STC     57**  
**IIC     51**

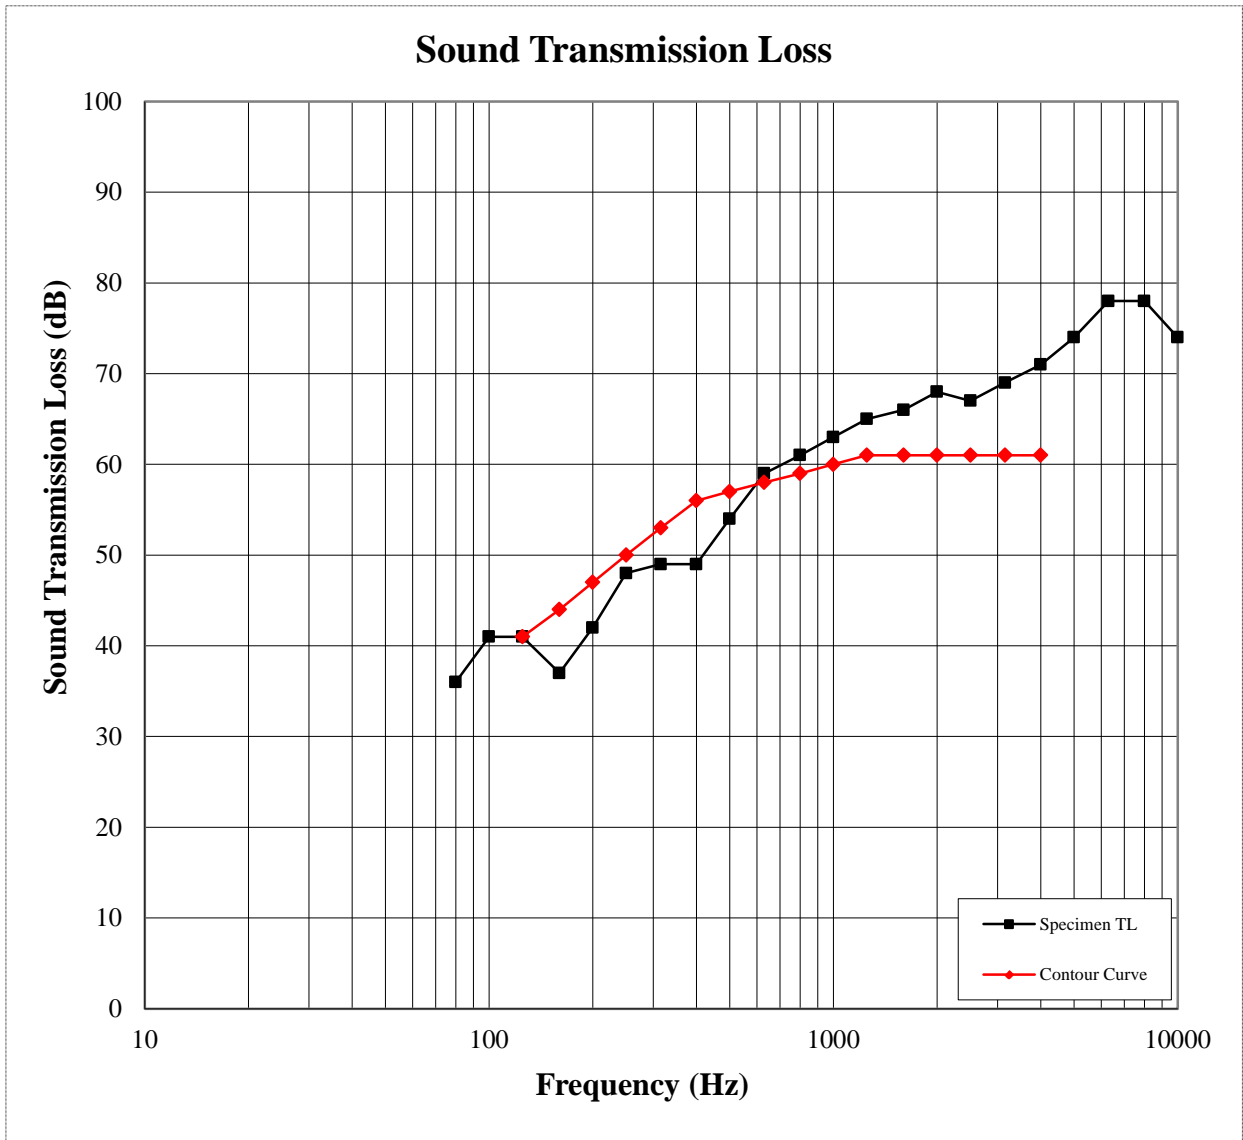
### SOUND TRANSMISSION LOSS ASTM E 90

<b>Test Date</b>	04/15/14
<b>Data File No.</b>	D6771.07
<b>Client</b>	Proflex Products Inc.
<b>Description</b>	7.2 mm Porcelain Tile, 5 mm Proflex Products, Inc. RCU 200 Rubber Underlayment, 203 mm Concrete Slab
<b>Specimen Area</b>	10.98 m <sup>2</sup>
<b>Technician</b>	Daniel B. Mohler

**STC Rating**      **57**      (*Sound Transmission Class*)  
**Deficiencies**      **28**      (*Sum of Deficiencies*)

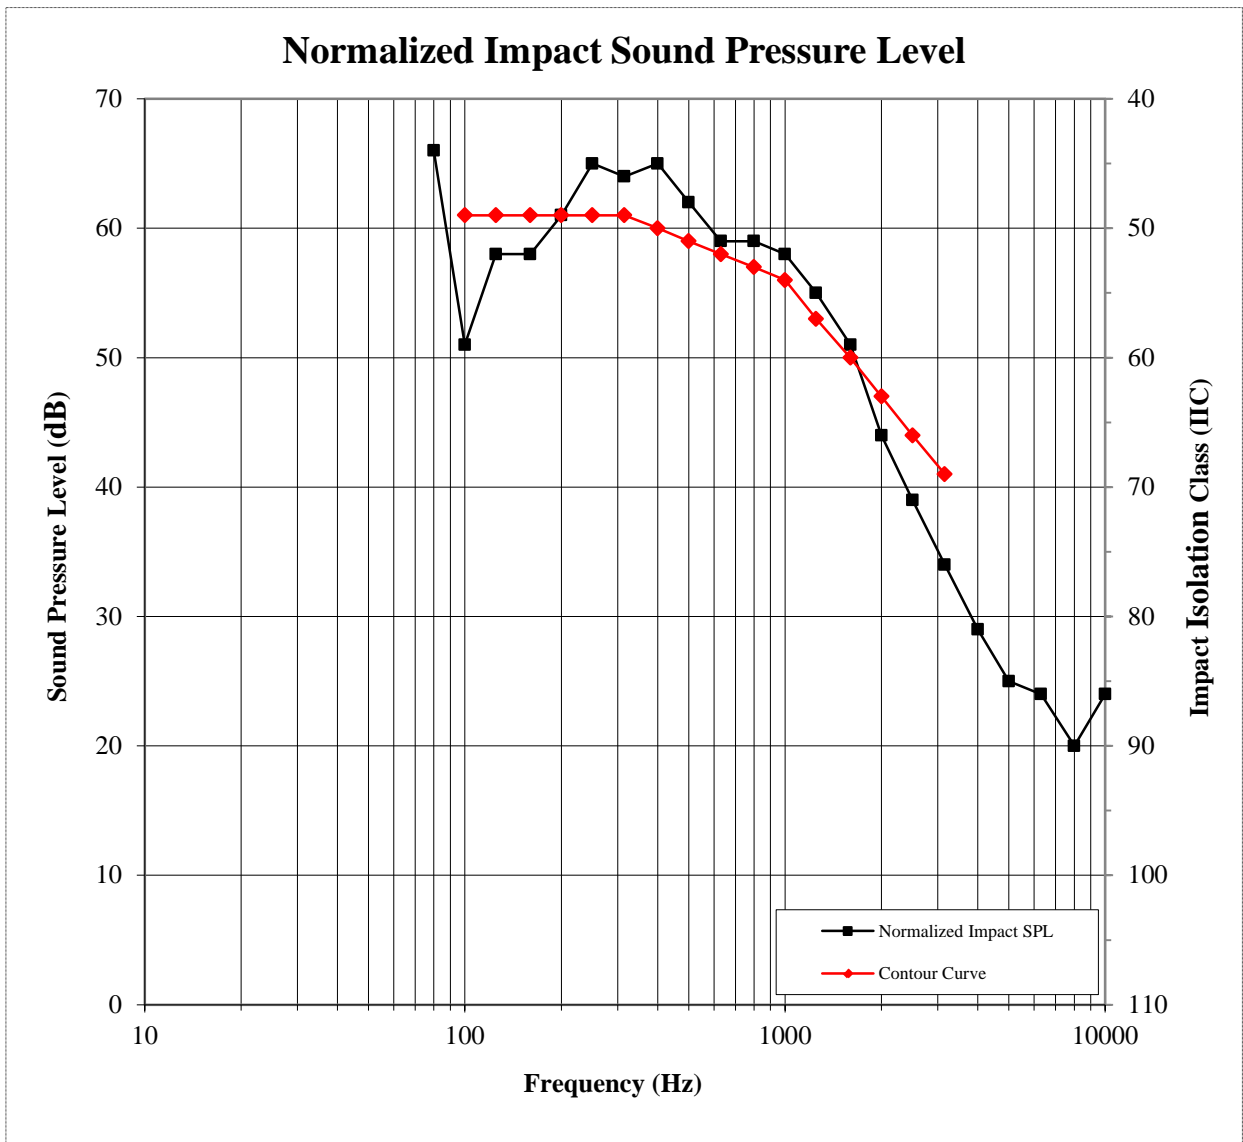
### IMPACT TRANSMISSION ASTM E 492

<b>Test Date</b>	04/15/14
<b>Data File No.</b>	D6771.07
<b>Client</b>	Proflex Products Inc.
<b>Description</b>	7.2 mm Porcelain Tile, 5 mm Proflex Products, Inc. RCU 200 Rubber Underlayment, 203 mm Concrete Slab
<b>Specimen Area</b>	10.98 m <sup>2</sup>
<b>Technician</b>	Daniel B. Mohler

**IIC Rating**      **51**      *(Impact Insulation Class)*

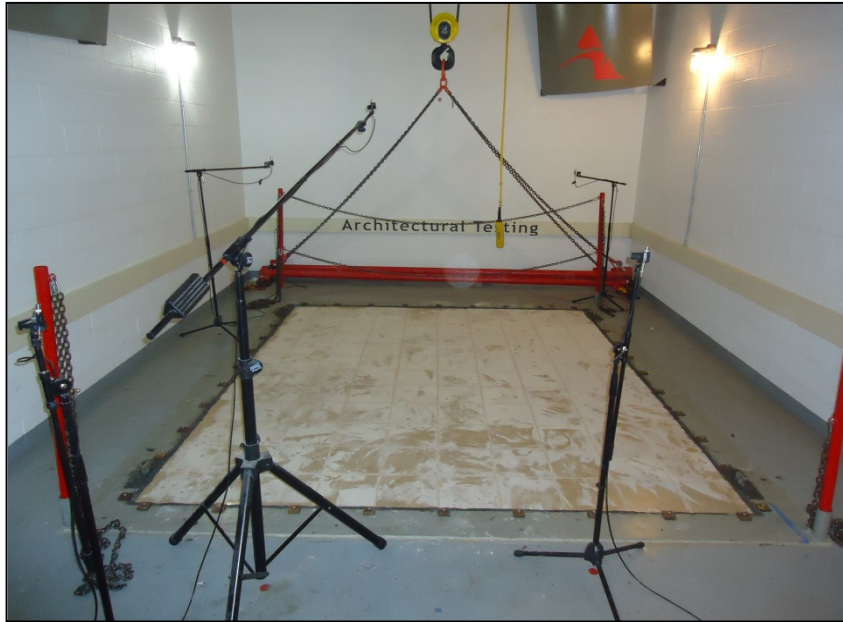
**Source Room View of Test Specimen Installation**

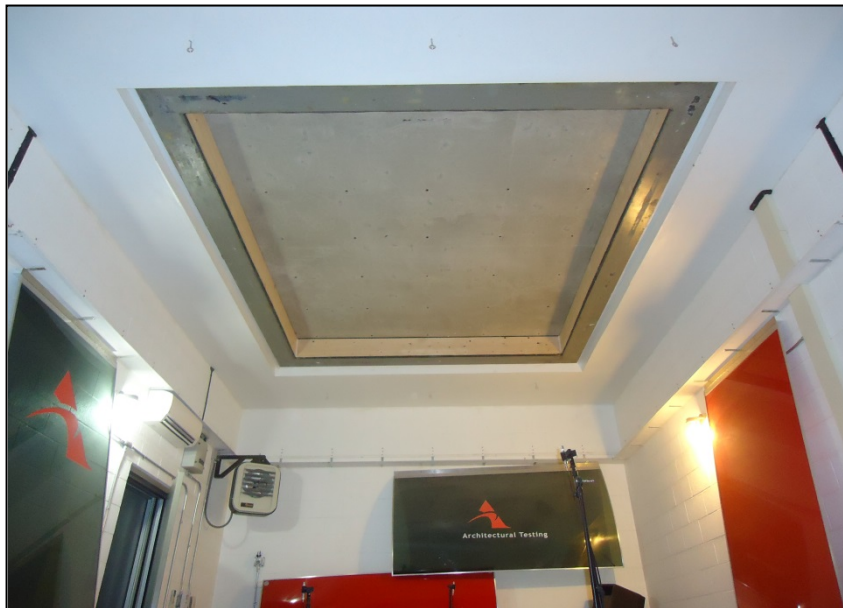
**Receive Room View of Test Specimen Installation**

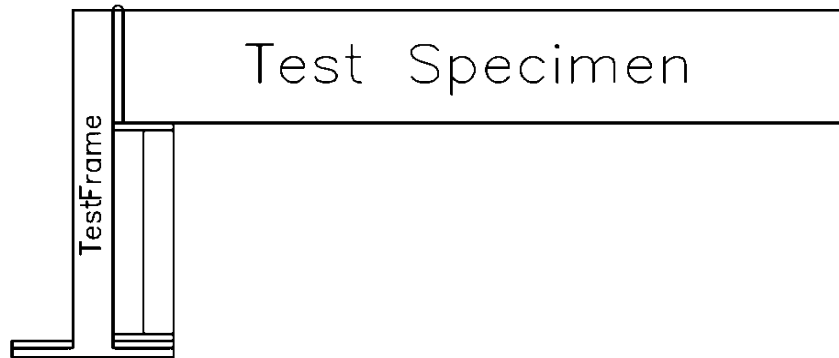
### Test Specimen Installation

### Cross Section View of Test Specimen

- 1 - Floor Topping
- 2 - Underlayment
- 3 - Concrete Slab

The porcelain tiles were set into the bed of mortar and separated by 6.35 mm spacers. Latex modified mortar was mixed as per manufacturer's specifications and troweled on top of the underlayment using a 9.53 mm by 9.53 mm square notch trowel. The mortar was allowed to cure according to the manufacturer's specifications. Sanded grout was mixed as per manufacturer's specifications and troweled into the 6.35 mm spaces between the ceramic tiles using a grout float. All excess grout was cleaned using a damp sponge. The grout was allowed to cure according to the manufacturer's specifications before testing. The perimeter of the porcelain tile floor was sealed to the test frame with duct seal.

A single layer of 5 mm RCU 200 was placed on top of the flooring adhesive within 30 minutes of application. The flooring adhesive was troweled over a protective layer using a 1.5 mm by 1.5 mm square notch trowel. A single layer of 0.05 mm polyethylene sheet was adhered to the concrete slab as a protective layer.

The concrete slab was installed into a test frame flush to the source room. The concrete slab was isolated from the test frame. The perimeter of the concrete slab was sealed with duct seal. Cure time for the concrete slab exceeded 28 days.
